# NBSIR 76-1068 (R)

# **Evaluation of A New Hardening Process for Steel Transfer Materials**

Failure Analysis Report

May, 1976

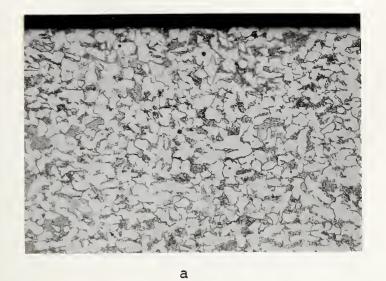
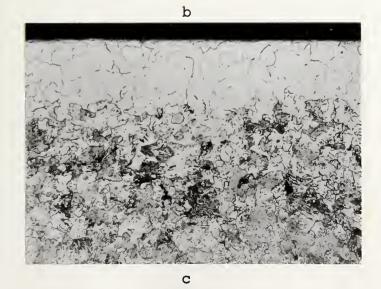
- Figure 1. Microstructures in Transfer Process Test
  Material Specimens, as-received. Etched
  with 4 percent nital. X 200
  - la. Specimen 1031-1. Partially spheroidized carbides in a ferrite (white) matrix. ASTM grain size, 8-9. No decarburization is present adjacent to polished surface.
  - 1b. Specimen 1045-1. Lamellar pearlite (dark) in a ferrite (white) matrix. ASTM grain size,7. No decarburization is present adjacent to polished surface.
  - lc. Specimen W2-1. Decarburized zone (white ferrite grains) adjacent to polished surface. Mixture of lamellar pearlite and ferrite in transitional zone between decarburized zone and core. Core structure consists of pearlite and ferrite.

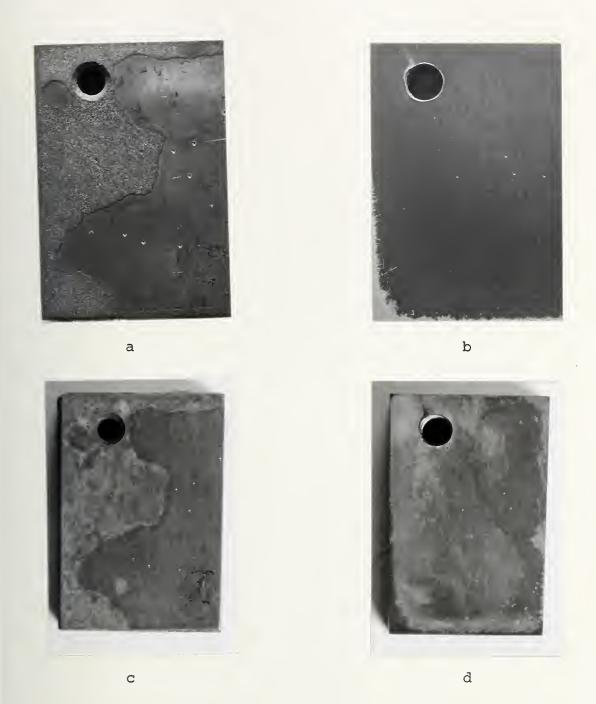
Figure 5. Appearance of polished surfaces of hardened specimens.

The surfaces of specimens hardened at the manufacturers laboratory were clean after hardening. However, some of the specimens hardened at NBS had a black, adherent coating after hardening. The coatings observed on the polished surfaces of hardened specimens 1031-14 and 1045-12 are shown in Figures 5a and 5b, respectively. was found that the coatings could be removed by immersion of the specimens in a 10 percent solution of sulfamic acid (NH2SO3H) at room temperature for from fifteen to thirty minutes, followed by swabbing with a soft bristle brush and a clear water rinse. The appearance of the polished surfaces of hardened specimens 1031-14 and 1045-12 after the sulfamic acid cleaning treatment are shown in Figures 5c and 5d, respectively. The black, adherent coating was observed on some of the specimens with low surface hardness reported in 5.2. It is uncertain as to whether the coating formed on specimens while they were in the salt bath; or was picked-up by specimens from a residual, substance on the surface of the bath, when specimens were being removed for quenching.

- a. Coating on specimen 1031-14 before cleaning
- b. Coating on specimen 1045-12 before cleaning
- c. 1031-14 after cleaning
- d. 1045-12 after cleaning

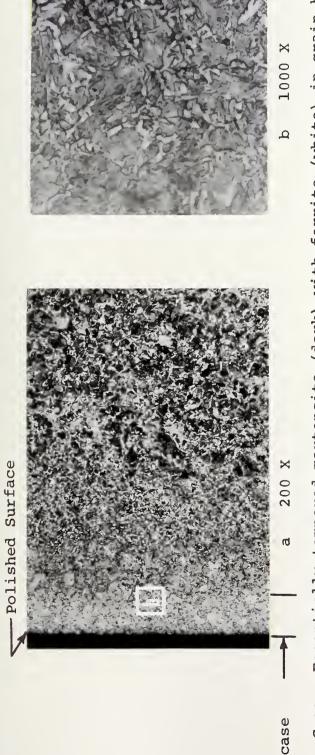
#### Specimen 1031-7 Figure 8.

Austenitized at 1550F 40 minutes; oil quenched; double tempered 75 minutes at 450F, Fresh salt bath. Hardened at NBS. 75 minutes at 425F.

Essentially tempered martensite (dark) with ferrite (white) in grain boundaries. Ferrite grain boundary network is prominent in transition zone. Case:

Range in case, 70 - 80.5 HR15N 74 - 75.5 HR15N on polished surface. Hardness:

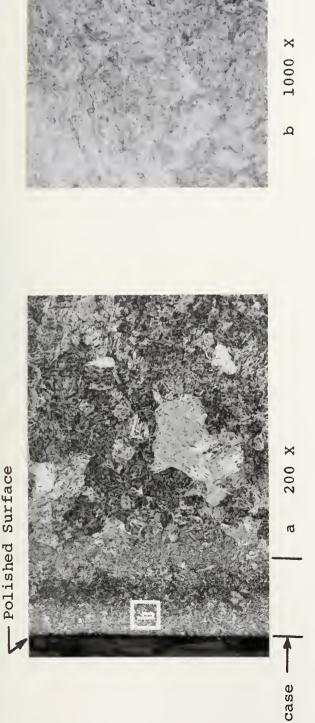
## Figure 18. Specimen 1045-14

Austenitized at 1480F 30 minutes; brine quenched; tempered 90 minutes at 400F. Hardened at NBS, LOCYN pellets added to salt bath for replenishment.

Case: Essentially tempered martensite.

Hardness: 76 HR30N on polished surface. Range in case, 73 - 74.5 HR30N.

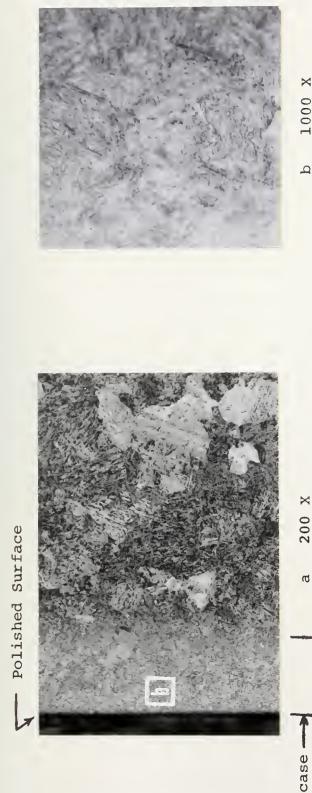
## Figure 19. Specimen 1045-15

Austenitized at 1480F 30 minutes; brine quenched; tempered 90 minutes at 400F Hardened at NBS. LOCYN pellets added to salt bath for replenishment.

Case: Essentially tempered martensite.
